Prichard Creek Assessment and Restoration Strategy

Trout Unlimited

December 2024

Inter-Fluve, Inc.
501 Portway Ave., Suite 101
Hood River, OR 97031

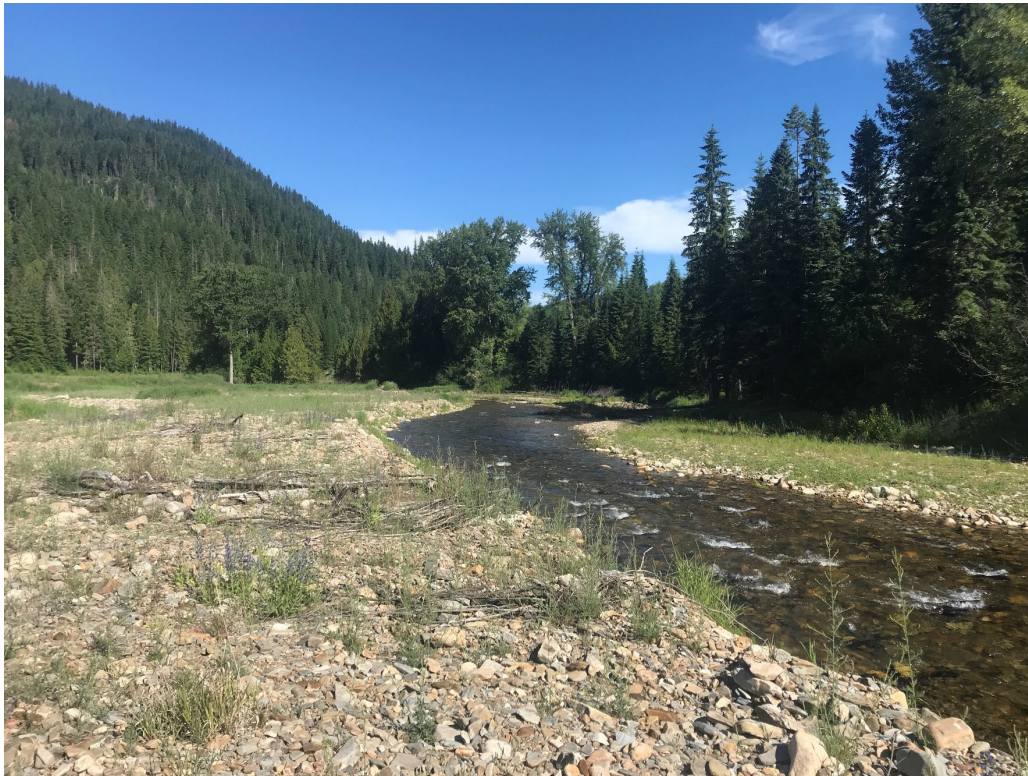
Figure 13. Shallow riffle habitats with little stream bank cover or instream habitat complexity are common throughout Prichard Creek.

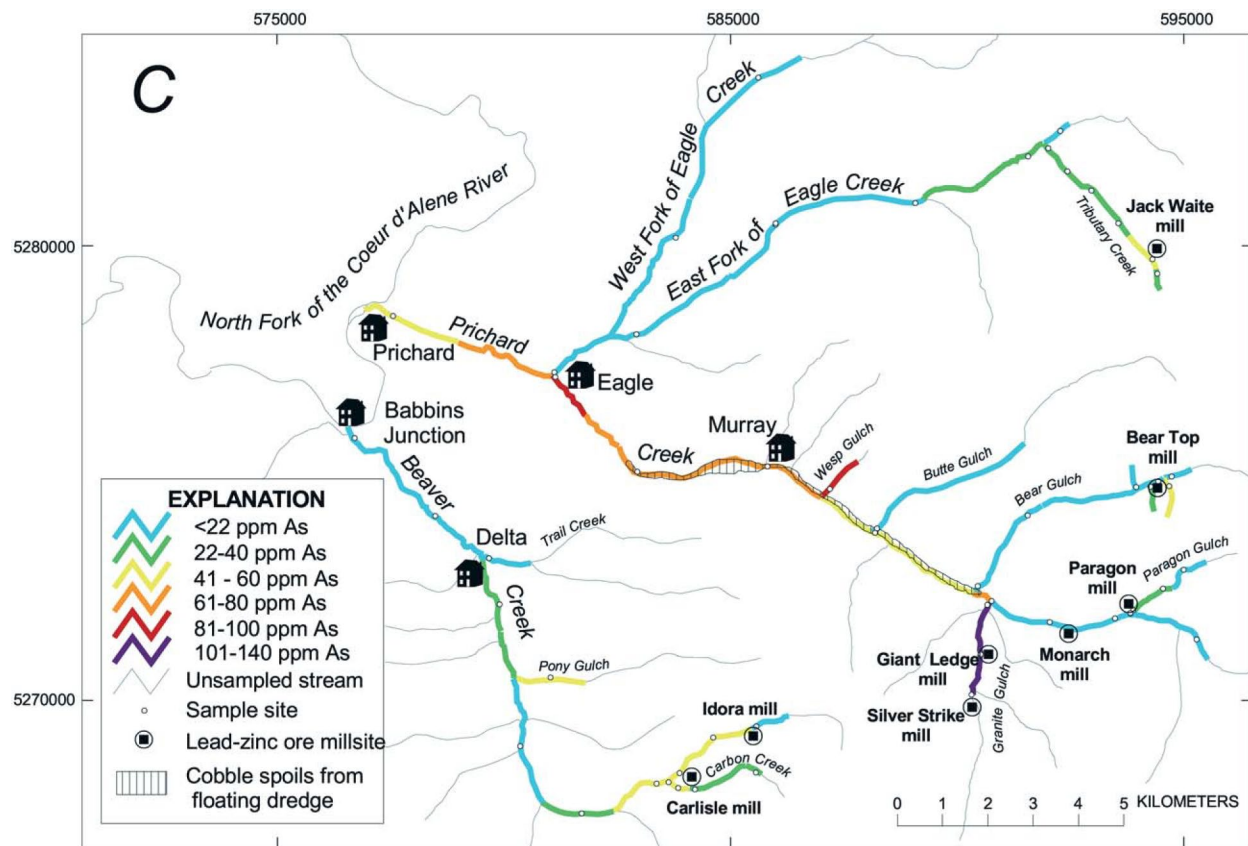
Figure 14. Arsenic concentrations peak on Prichard Creek between Murray and the Eagle Creek Confluence (from USGS, 2004).

Elevated levels of metal contaminants in Prichard Creek may reduce potential for high-quality habitat in these reaches. Woodward et al. (1997) found cutthroat trout avoided water with relatively low concentrations of cadmium, copper, lead, and zinc (2004 and 2021 samples show significantly higher levels in Prichard Creek).

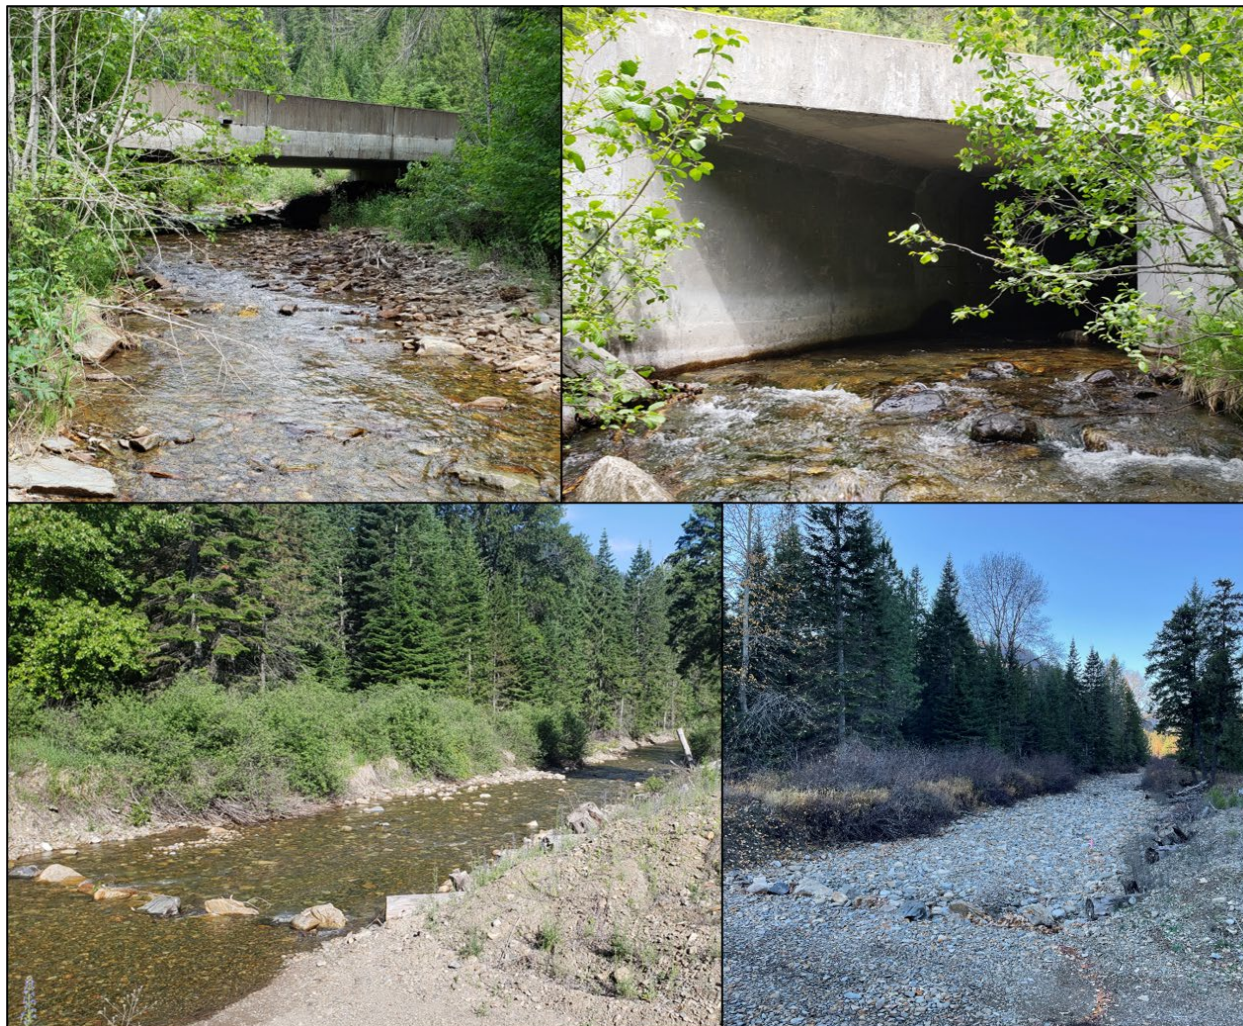
In the project area, the primary AOP barrier is that the creek flows subsurface from RM 4.4 to RM 6.7 (approximately) for portions of the year (Figure 15). Based on our observations and conversations with locals, the creek through this stretch can go from flowing to dry in the span of a day. This behavior is a direct result of the dredging that occurred in the past, as the dredge effectively turns over the floodplain. Fine sediments that would have slowed subsurface flow flush downstream, leaving an overly coarse and sorted substrate through which water can easily infiltrate. As part of this project, TU and IFG have installed a network of monitoring wells that will provide seasonal and spatiotemporal information on groundwater levels. This information will be used to determine potential restoration strategies.

Figure 15. Crossings on Butte Gulch (top left) and RM 12.3 (top right). The show a downstream view of Prichard Creek, taken near RM 4.7, of water flowing in late June (lower left) and dry in November (lower right).

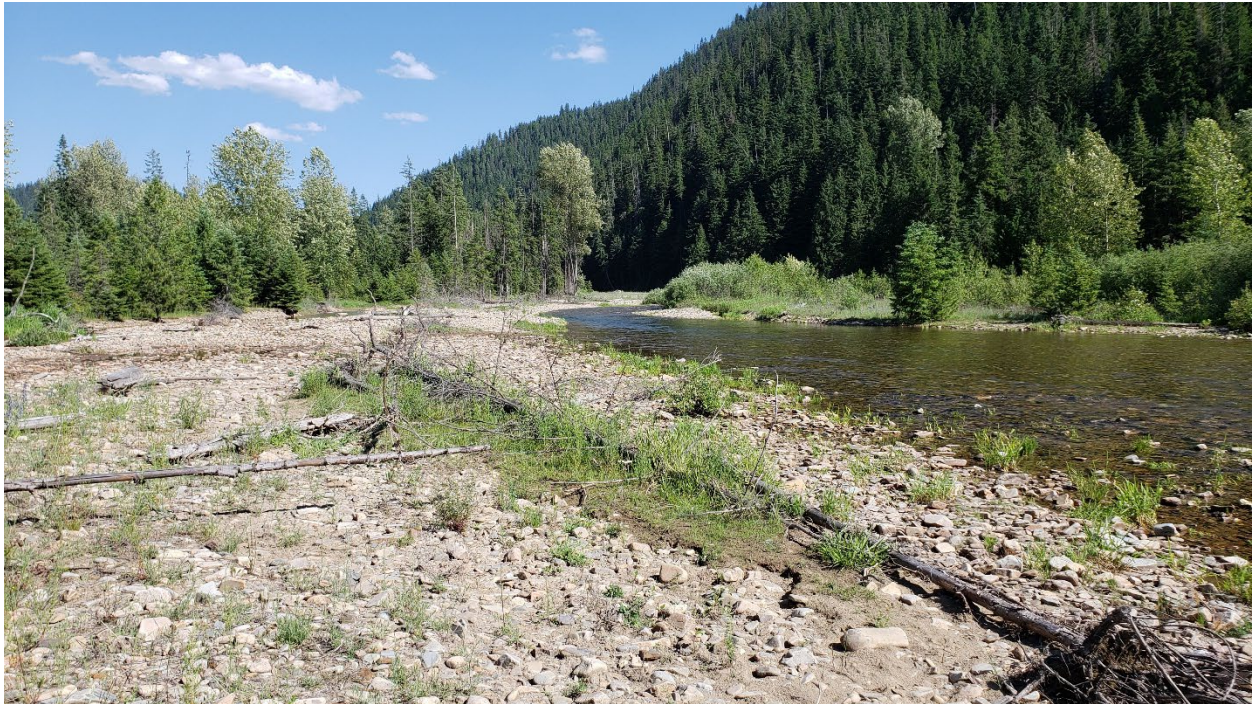
both wet and dry multi-thread channels, all of which have homogenous, plane bed profiles over cobble and gravel substrates (Figure 17Error! Reference source not found.).

Figure 17. Prichard Creek at RM 1.2. Plane bed channel segments like this one offer little or no fish habitat, and the small, mobile bed material sizes offer limited stable attachment sites for macroinvertebrates.

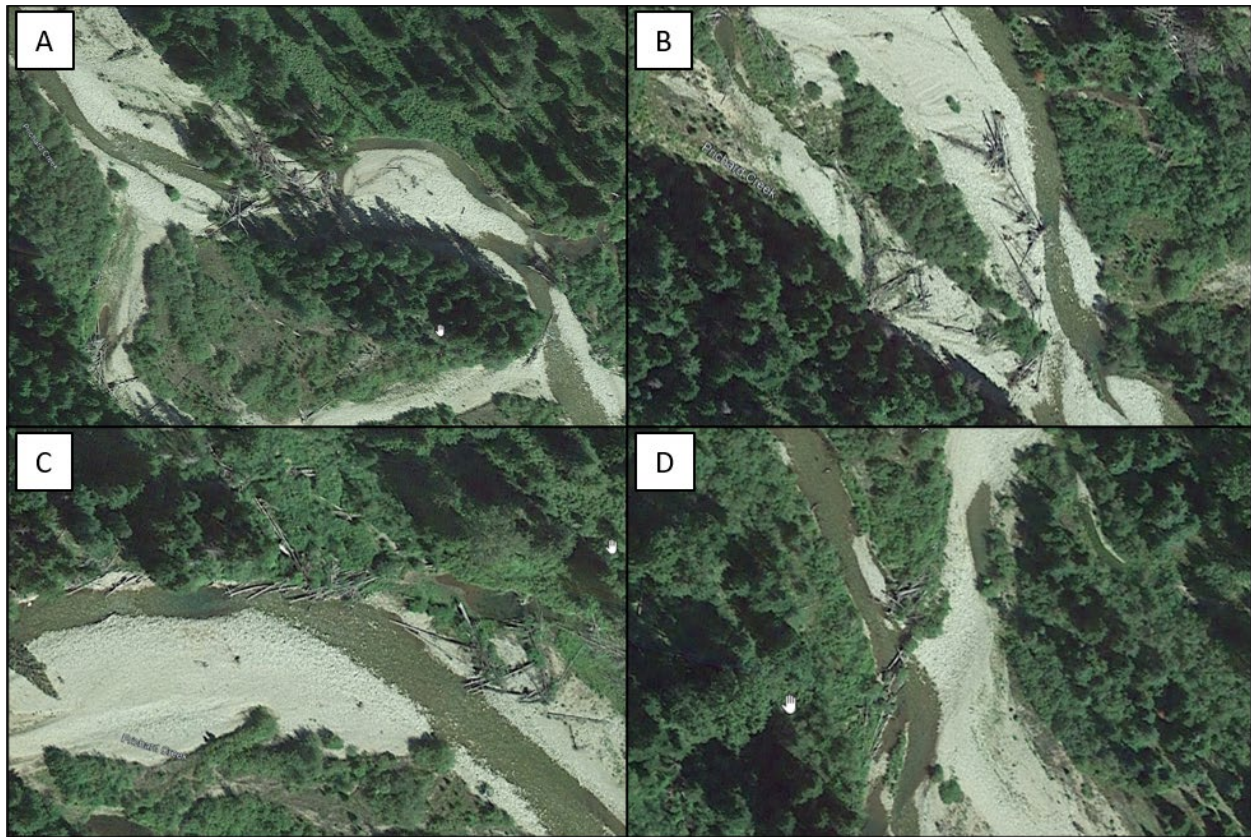
Large wood protruding from banks and accumulated along bank margins provide some cover for fish, but these jams vary in associated pool habitat. There are a select number of large log jams at meander bends that offer complex bed forms, overhead cover, and deep pool habitat.

Figure 18. Large wood accumulations in lower Prichard consist mainly of a) channel spanning jams that cause channel departures or multi-threading, b) mid channel structures that guide the main channel, c) racked bank accumulations, and d) apex bar jams or racked wood at the head of vegetated islands.

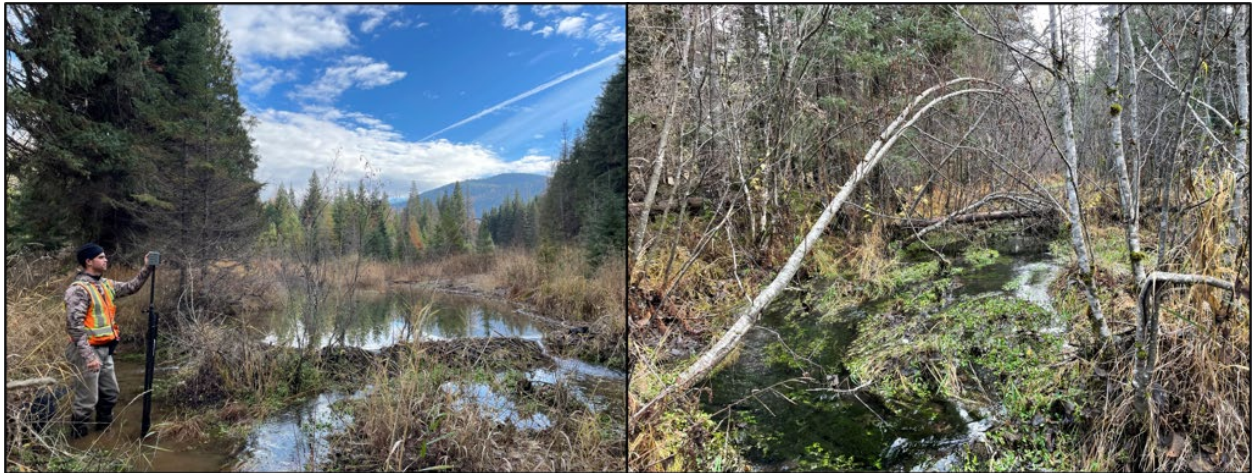
From 3.2 to 4.0, beaver activity has created split flow conditions in this segment (Figure 24), and large wood accumulations have diverted flow into wooded floodplain areas, either through existing relic channels or in newly created side channels varying in width from 5-20 feet. Juvenile fish were observed in the side channels.

Figure 24. Beaver ponds in Reach 3 (left) is driving the development of new channels through the river right floodplain (right).

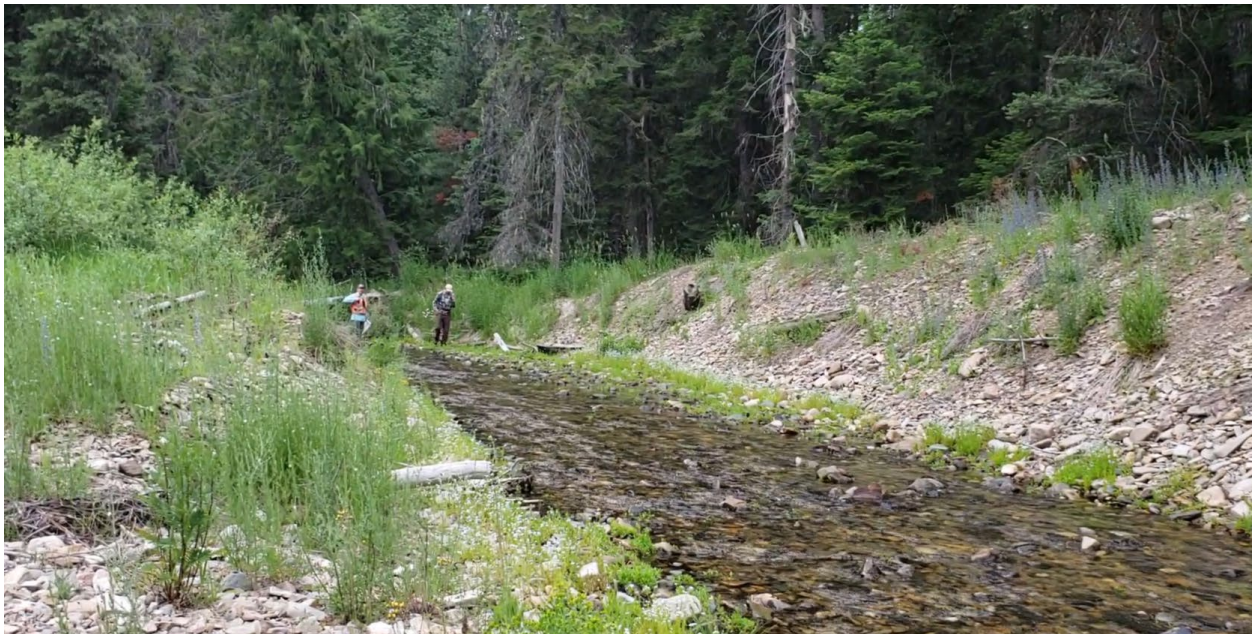
Banks along the main channel are 2.5-3.5 feet in height, composed largely of mining spoils, gravel, and sand. The channel bed through this reach is featureless and plane bed, with smaller gravel and cobble sizes, compared to Reach 1. Mobile bars are frequent. Much of the mobilized sediment through this reach has transported through and deposited between RM 4.0 and RM 4.2. The valley is confined at RM 3.8, likely resulting in backwater at RM 4.0 and precipitating sediment deposition. Multiple smaller channels flow through bar deposits in this segment.

Figure 25. Photo looking downstream in the prominent side channel in Reach 3. Dredged material used to create a berm is visible on the right side of the photo (right bank).

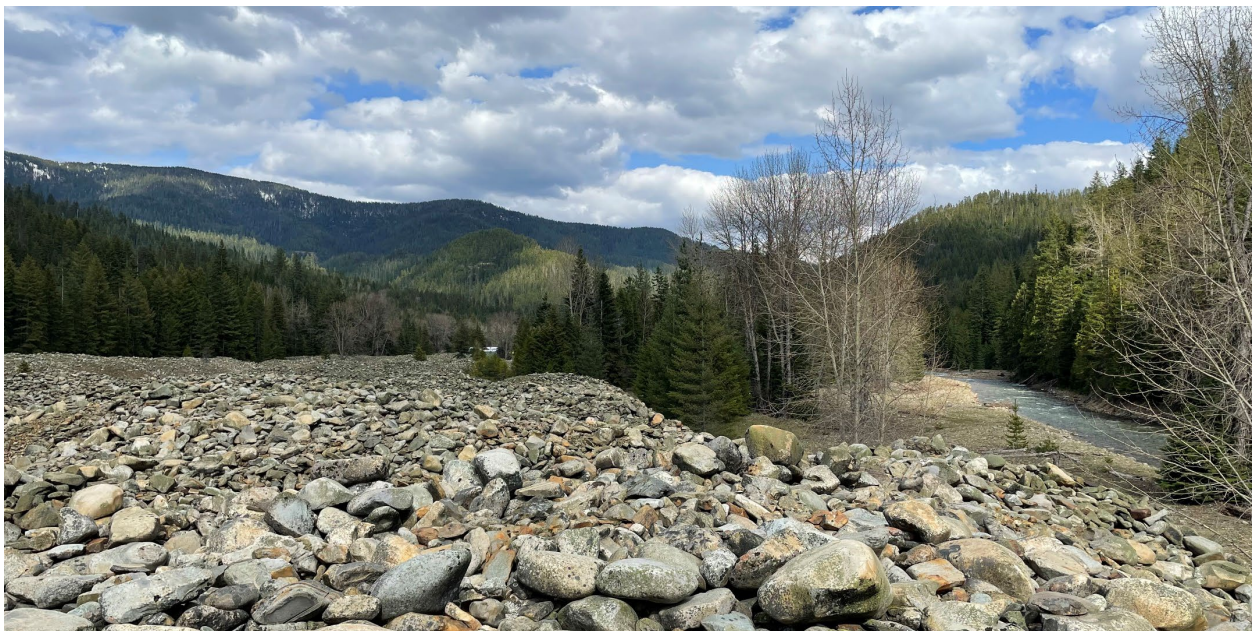
Dredge spoil piles remain unvegetated in these floodplains (Figure 33) and very little riparian vegetation is present that could provide shading or cover habitat for fish in this reach. Low active floodplain surfaces consist of gravel and sand, and remain largely unvegetated. Ponded areas and pools that are present in these floodplains, fed by groundwater or precipitation, are isolated from the main channel and therefore provide no fish riverine habitat.

Figure 33. Prichard Creek is confined between unvegetated dredge spoils and the southern valley toe. View is looking upstream.

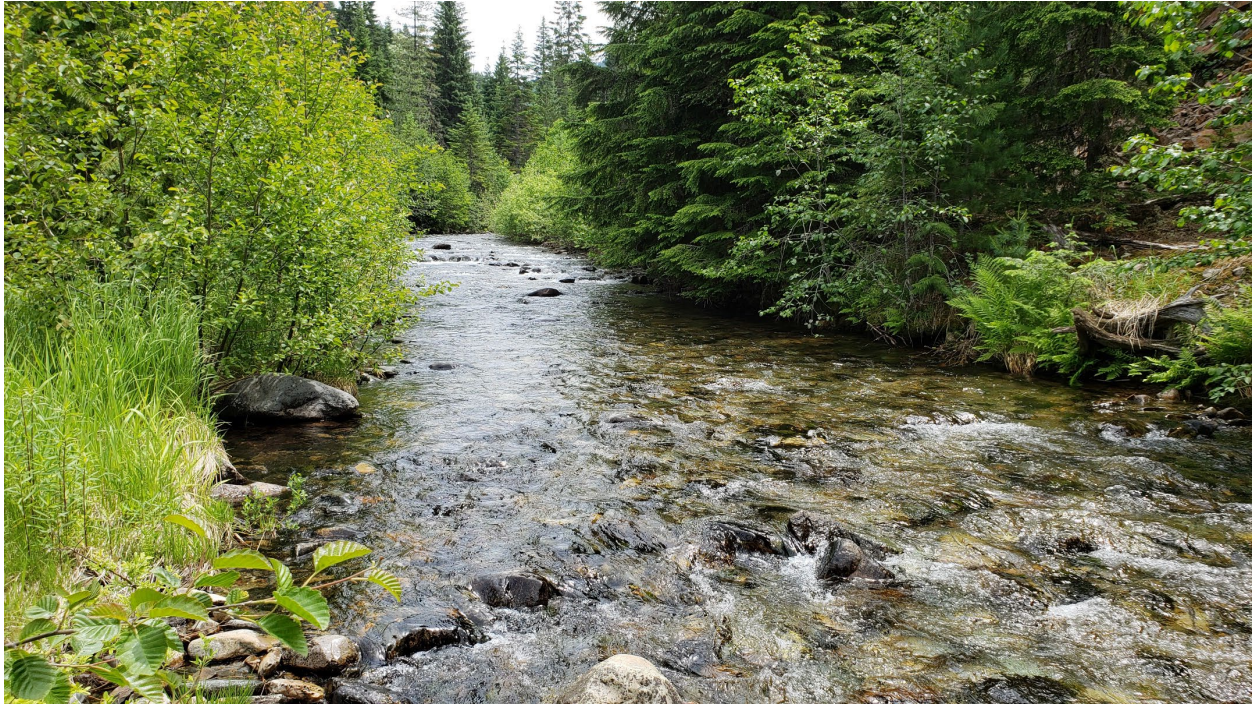
Though much of Reaches 11 and 12 show a multi-thread channel pattern, the dominant flow path is aligned almost directly down valley. The side channels likely offer high flow refuge, but most lack roughness (e.g., wood) and vegetation and may be quickly overwhelmed at high flows. Bed complexity is limited and mostly related to boulders and larger clasts that have organized into steps and rapids (Figure 38). One large wood jam is located in the upper portion of this reach. Riparian vegetation is relatively sparse in this reach however, offering limited shade (shade trees cover approximately 1% of the riparian in Reach 11 and 10% in Reach 12) and bank cover habitat for fish.

Figure 38. While mostly plane bed, larger clasts have organized into steps through reaches 11 and 12.
