Prichard Creek Assessment and Restoration Strategy

Trout Unlimited

December 2024

Inter-Fluve, Inc.
501 Portway Ave., Suite 101
Hood River, OR 97031

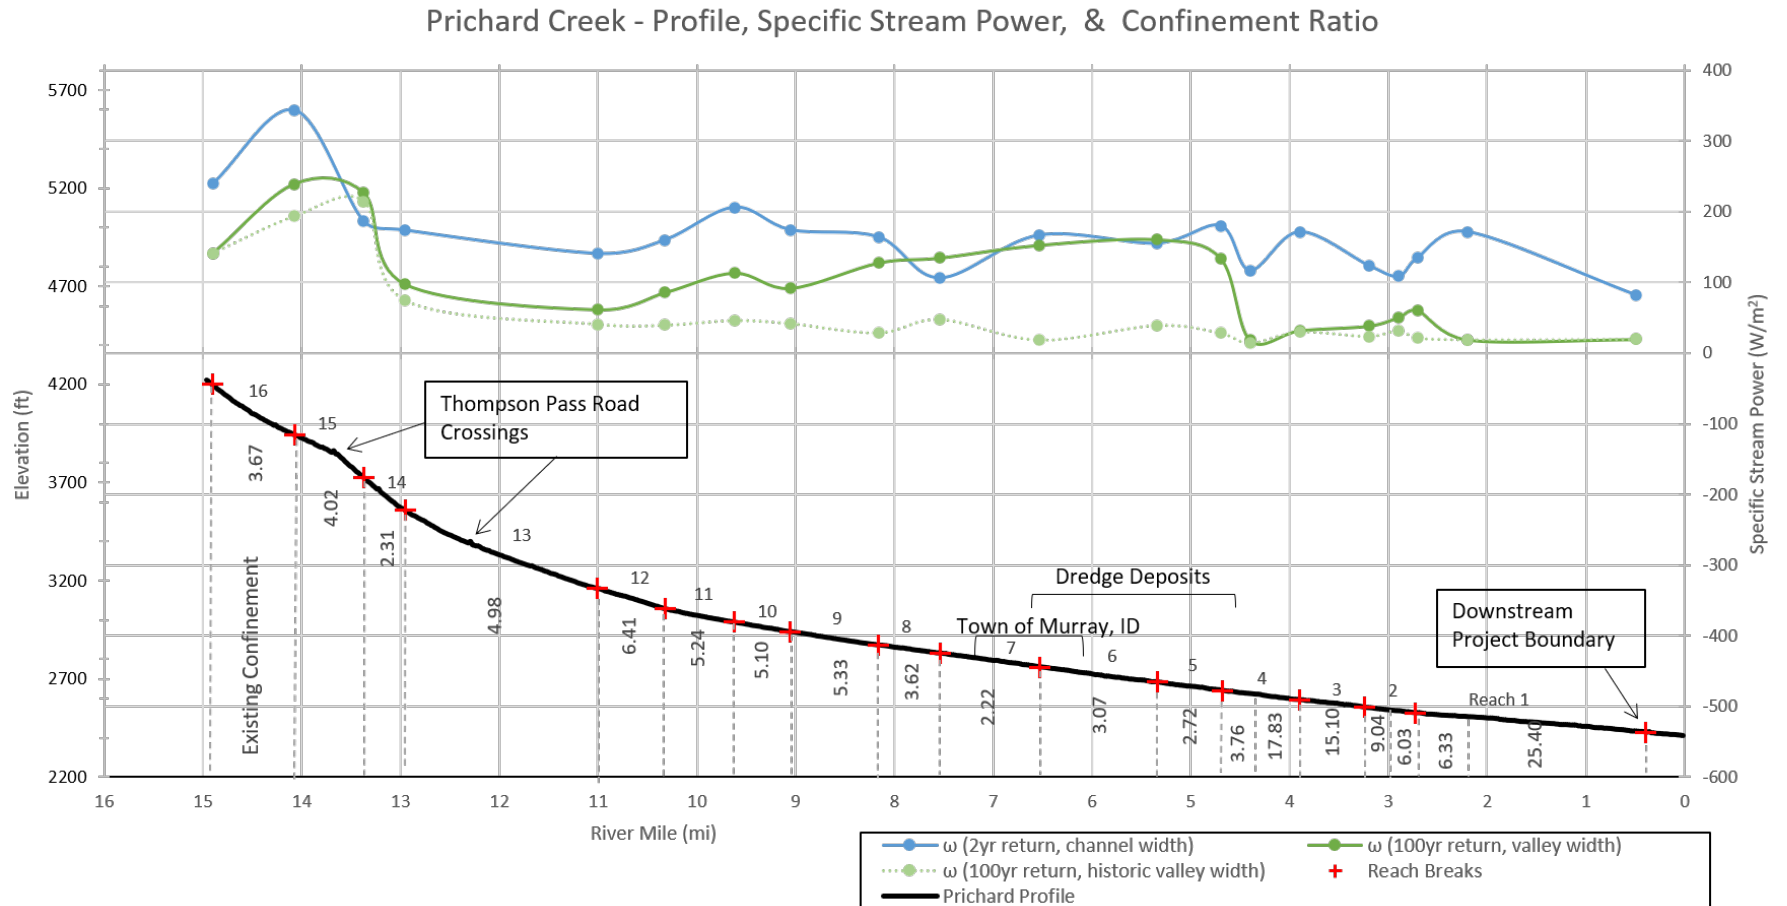
Referring to Figure 11, the diversion of the channel forming (blue) and inundation stream power (green dashed) from the historic inundation (green) is in part due to the added channel and floodplain confinement from human development and mining deposits. The main impact of this increased confinement from human development in the central reaches of Prichard Creek is that the function of these transitional reaches between the upper and lower watershed is greatly decreased. This transition zone typically functions as a geomorphically complex energy dissipation zone which protects the lower reaches from increased flooding with the supply of fast water and increased sediment from the upper mountainous reaches. The central reaches would have historically had more access to the floodplain, allowing for wider streams with slower flow and the development of riffles and pools which increase roughness and decrease the overall energy of the flow. The increased confinement of these reaches makes them narrower, straighter, faster, and higher energy than historically, which allows for increased transport of sediment, evidenced by higher stream power (and the divergence from the historic stream power). This sediment then deposits in the lower, less confined reaches. As the flow slows down and spreads out in the lower reaches, more sediment drops out and chokes the stream, creating a braided flow pattern and increasing the impact of flooding. The trend in historic inundation stream power follows a more predictable pattern of high in the upper reaches which tend to be steep and confined with a steady decrease as the channel becomes wider and less steep.

Figure 11. Prichard Creek profile from river mile (RM) 14.9 to 0.6 mi upstream of the confluence with the North Fork Coeur d’Alene (indicated as the downstream project boundary). Confinement ratio for reach each shown below the profile and separated by dashed lines. Reach breaks indicated with red crosses and labelled above the profile. Stream power plotted in green and blue above the profile and calculated for each reach.

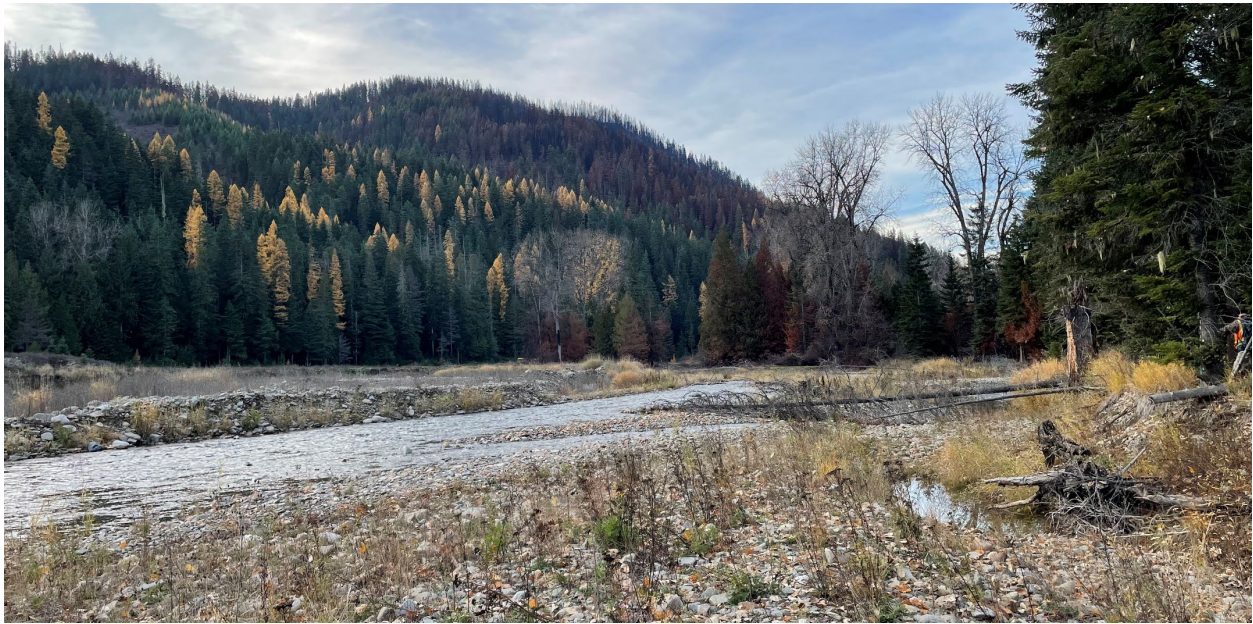
Reach 2 is confined by Thompson Pass Rd which also has a bridge where it passes over the confluence with Eagle Creek. There are a few gravel roads that cross the floodplain as well as houses along the banks of the channel. A berm has been constructed near RM 3.3, presumably to protect the road. The main human alteration in this group of reaches is the Four Square mine (Figure 20) and the dredge spoils in Reach 4. Vegetation clearing associated with the mining operation likely contributed to the channel avulsion experienced in 2011 or 2012.

Figure 20. Prichard Creek though the Four Square Mine is braided and lacks a vegetated riparian zone.

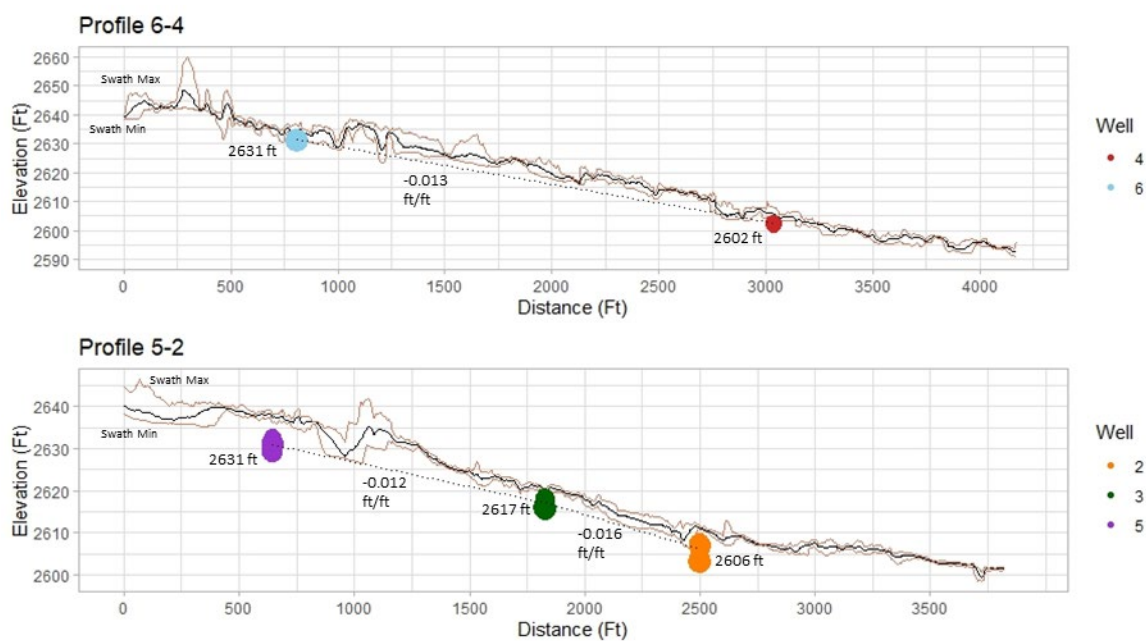
To understand the impact of the dredging on surface water flows, water surface elevations (WSE) were monitored in five wells through the reach (Figure 21). Table 3 displays select descriptive statistics for the wells in Reach 4; Figure 22 and Figure 23 show elevations relative to topographic cross sections and profiles. WSE slopes in the down-valley direction approximately match the overall valley slope of 0.013 ft/ft. In the upper portion of reach four, the water surface maintains a similar average elevation on both sides of the valley, with a mean elevation of 2631.0 and 2631.2 at wells 5 and 6, respectively. Moving down the reach, the ground water remains higher on the right side of the valley, with well two having a mean elevation 4.1 feet above that of well four. The WSE in wells four and six, on the river left side of the valley, are on average closer to the surface than wells two and five, which are located on the river right side of the valley. The former Prichard creek alignment is a few feet higher than the current main channel, and is flanked by a mostly intact floodplain. Tributary and hillslope runoff and a fluvially-sorted soil structure likely help maintain higher WSE on that side of the valley. These monitoring results suggest that water is close to the surface (i.e., within a foot) through Reach 4.

Figure 22. WSE profiles showing the data of profiles depicted in Figure 21. Colored dots show the range of elevations for that well. The most frequently occurring elevation is labeled. The slope of the water surface is labeled. Topography is from LiDAR and brown lines represent a 50 m swath to show local variability.

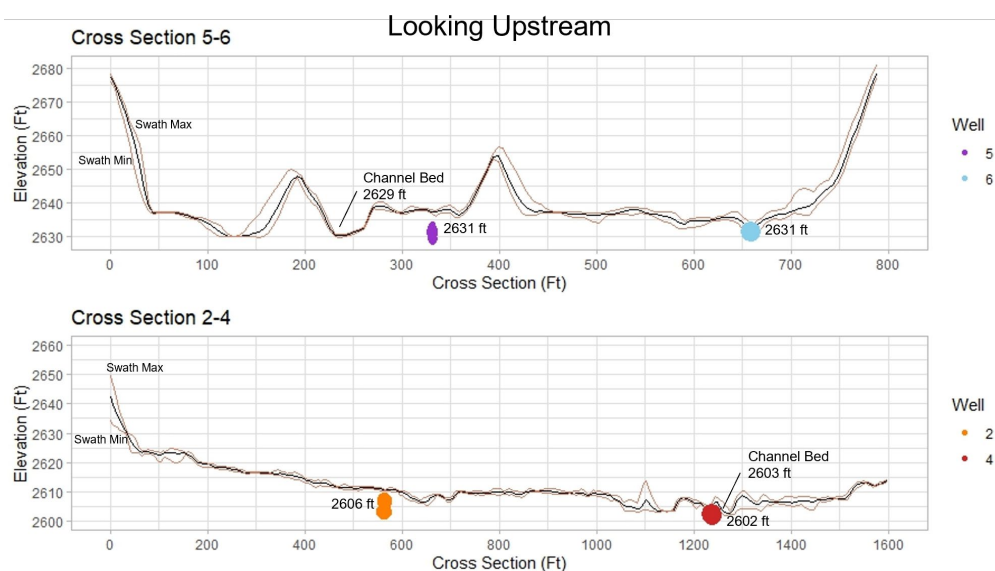
Figure 23. Cross sections showing how WSE vary across the floodplain for paired wells. Topography is from LiDAR and brown lines represent a 50 m swath to show local variability.

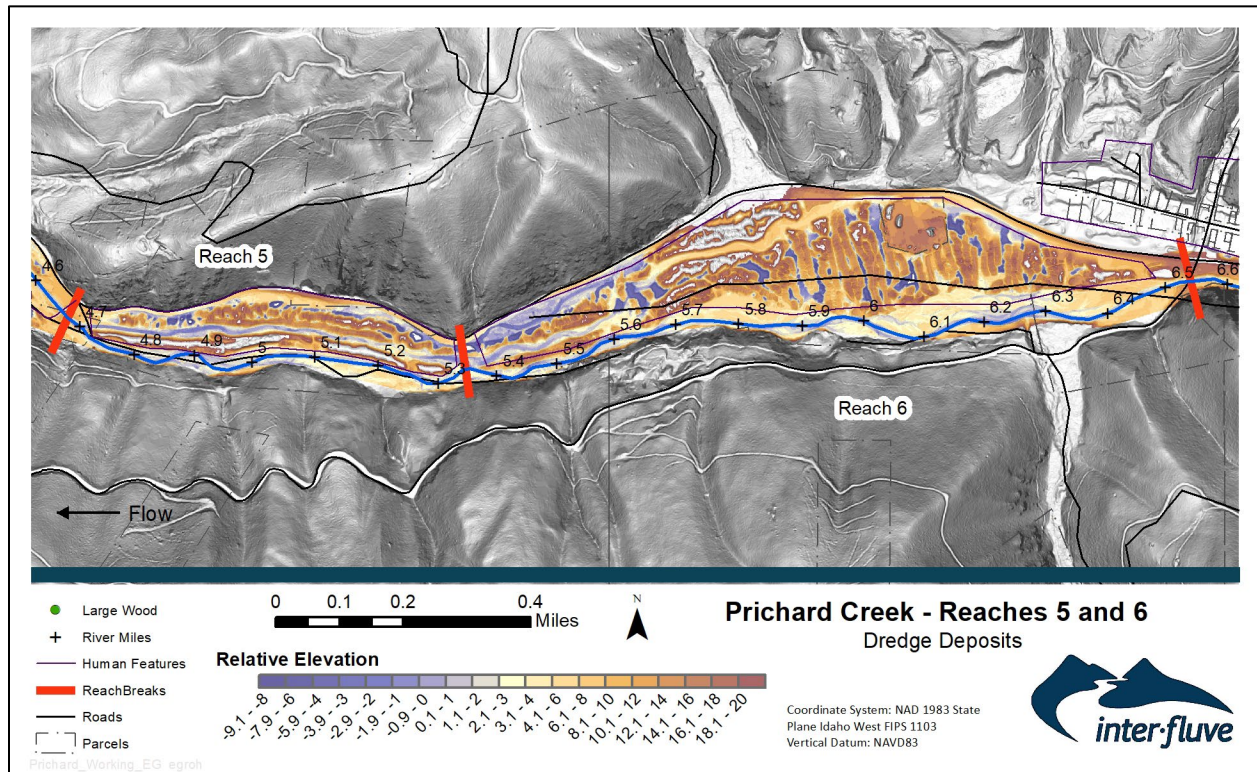
Reaches 5 and 6 are characterized by dredge mining deposits, visible as lateral ridges and troughs on the north side of the river in Figure 26. These dredge deposits not only confine the river and occupy the floodplain but also change the hydrology of Prichard Creek, causing surface flows to go subsurface through the turned-over floodplain sediments.

Figure 26. Overview map of Reaches 5 and 6.

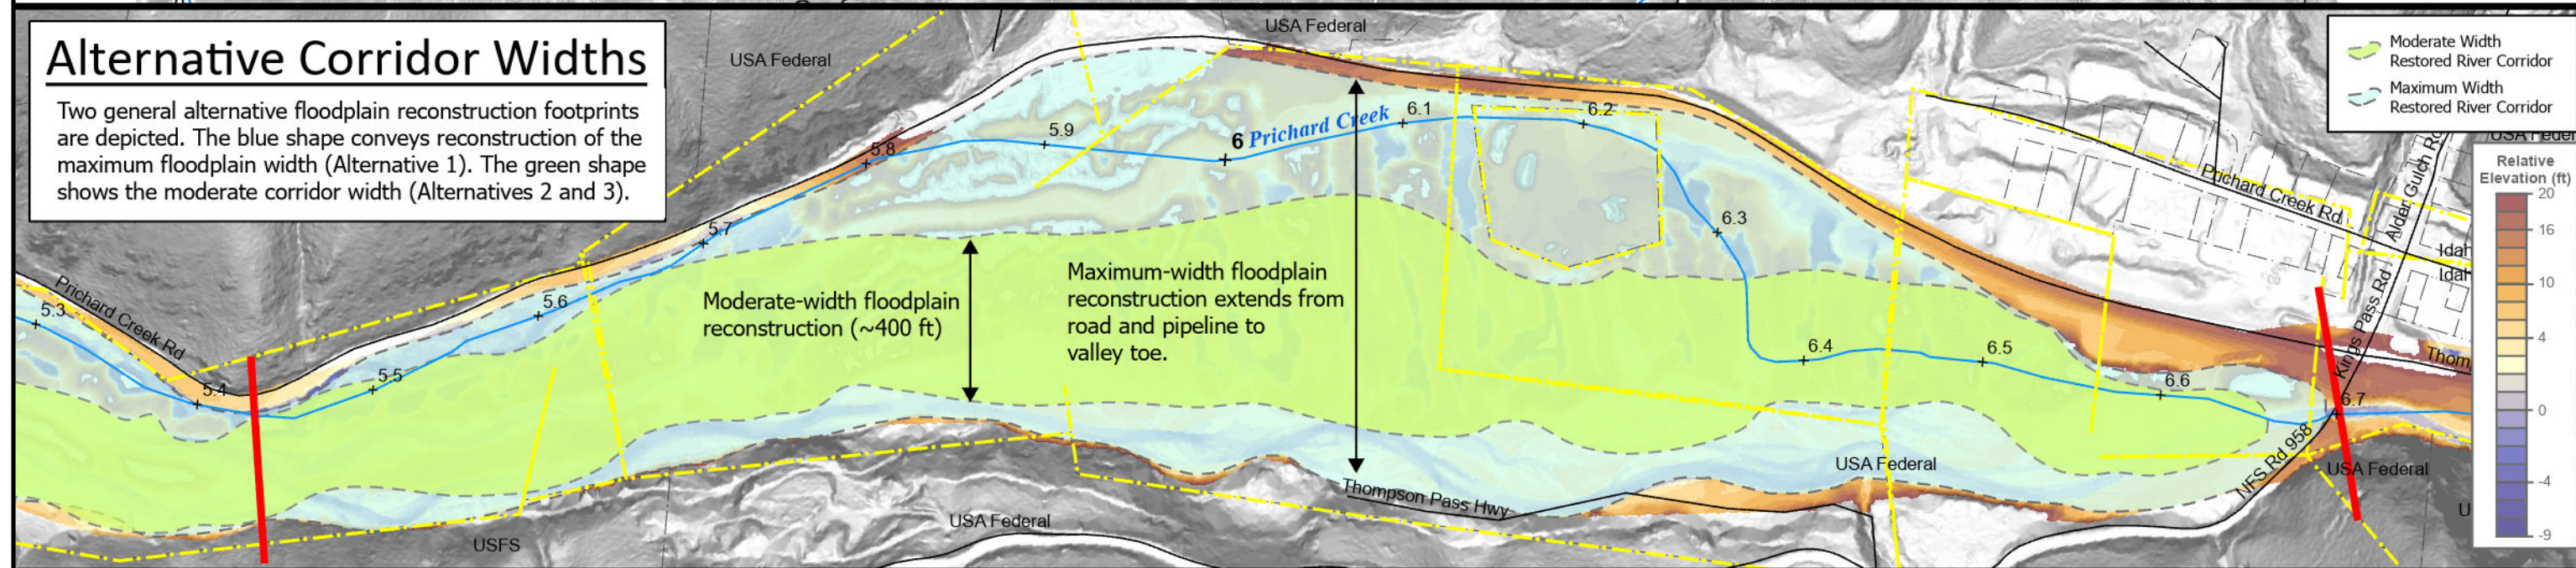
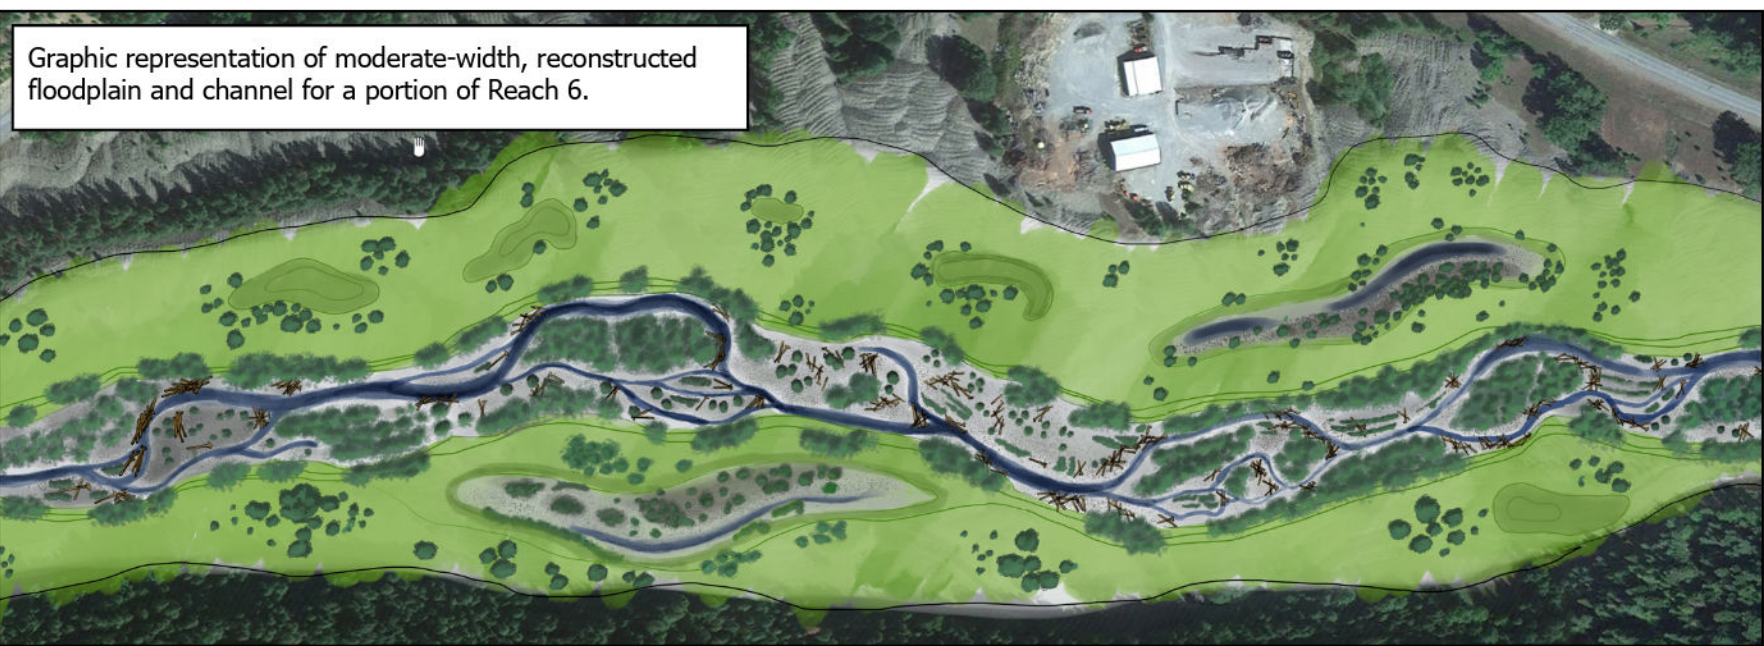
REACH
5

Two general alternative floodplain reconstruction footprints are depicted. The blue shape conveys reconstruction of the maximum floodplain width (Alternative 1). The green shape shows the moderate corridor width (Alternatives 2 and 3).

Proposed alternatives for Reach 6 involve reconstructing the floodplain at an elevation at or closer to the low-flow groundwater elevation. The graphics below depict existing (left) and proposed (right) condition section views of a typical section of channel in reaches affected by the dredge. Under existing conditions, the reach is losing and flows subsurface during low-flow times of the year. Under proposed conditions, the river corridor is recreated at an elevation and slope that maintains year-round surface flows.

Graphic representation of moderate-width, reconstructed floodplain and channel for a portion of Reach 6.
